Condition surveys of painted wood in the church of Hedalen, Norway: a support from the advanced optical techniques

Tone Marie Olstad, Norwegian Institute for Cultural Heritage Research NIKU

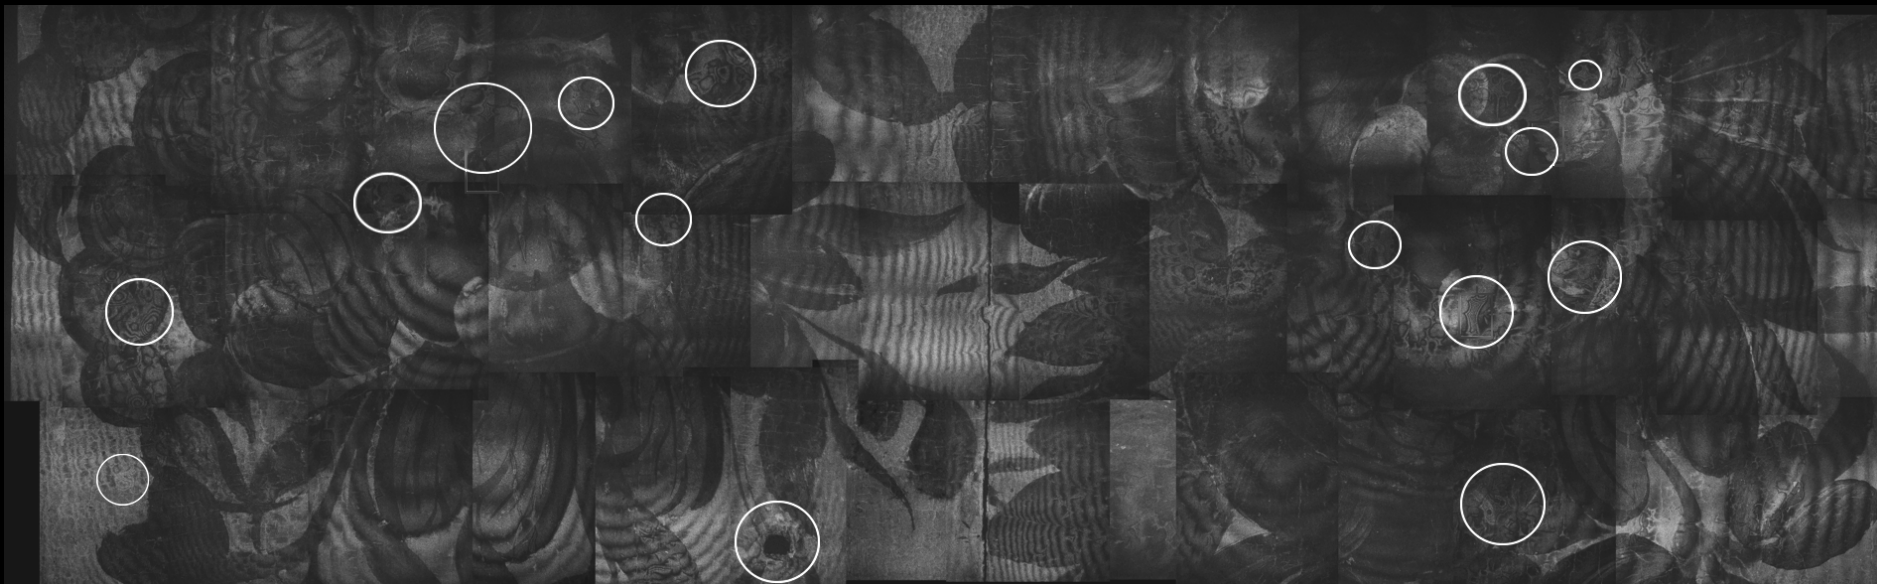
15 areas with possible loose paint

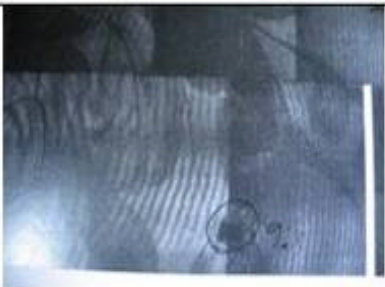
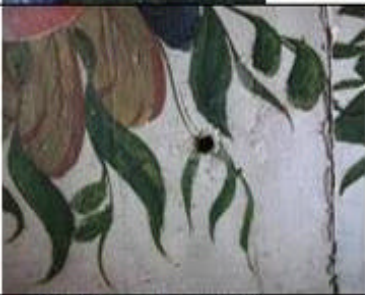
Variations in the original paintlayer in the area. Differences between the original paint and retouchings. No loose paint/visible damage	As Tone
9

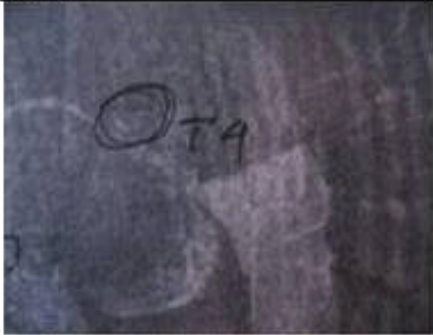
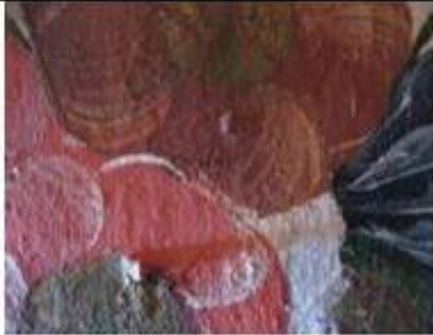
NO	Photo	Photo	Tone's Comments	Mille's Comments (the day after)
T4, left

No loose paint	As Tone
	<p>Below the indicated area</p>

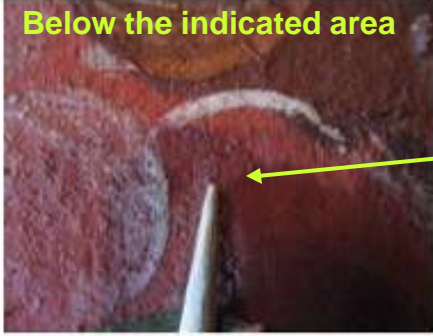
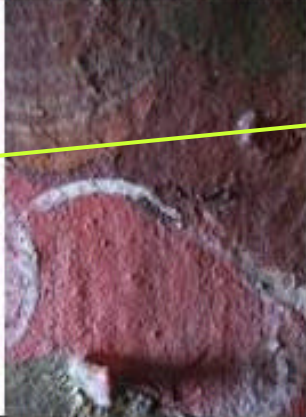
Most probably loose paint marked with stick	As Tone

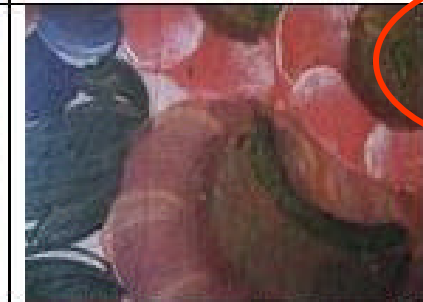
NO	Photo	Photo	Day 1 Tone's Comments	Day 2 Tone's Comments (the day after)
D4

Crack. Loose paint	L-shaped crack, about 5mm high and 2 mm wide, loose paint! Corresponds with alterations seen in the ESPI-images (November 2008 and april 2009). See arrow.

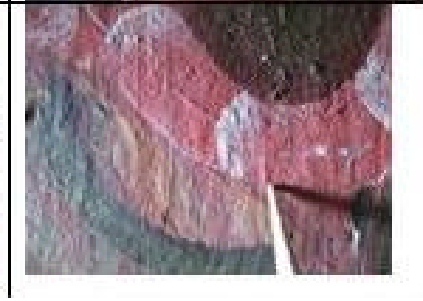
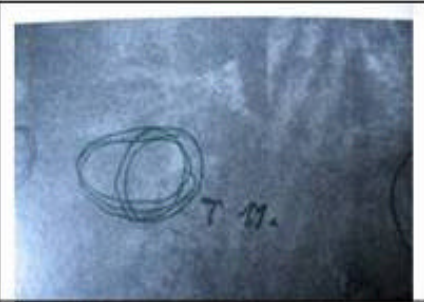
T11

No loose paint/visible damage. <u>Loose paint below T11</u>	As Tone
	Below the indicated area

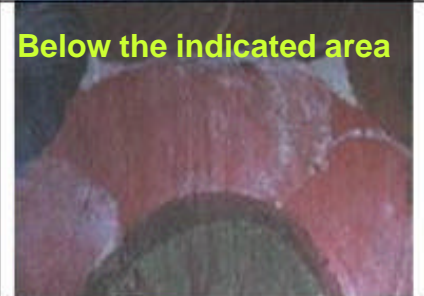
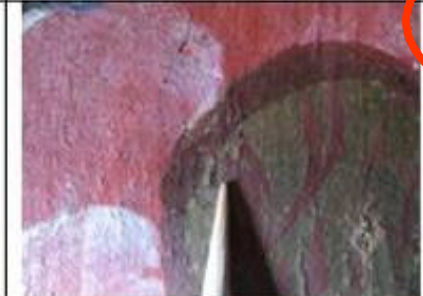
Loose paint marked with the stick	As Tone
