THE IMPACT OF THE ENVIRONMENTAL CONDITIONS AND CONSERVATION TREATMENTS ON THE CONDITION OF PANEL PAINTINGS

CASE STUDY ON THE BASIS OF THE PANEL PAINTING “CONCERT” FROM THE 16TH CENTURY, VENETIAN SCHOOL

WAWEL ROYAL CASTLE
OLIWIA BUCHWALD-ZIECINA
CONSERVATOR
www.wawel.krakow.pl
oliwia@onet.pl

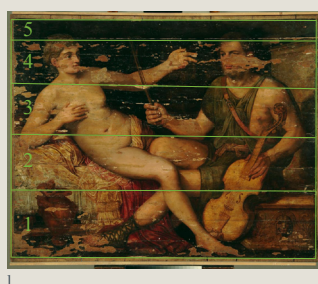
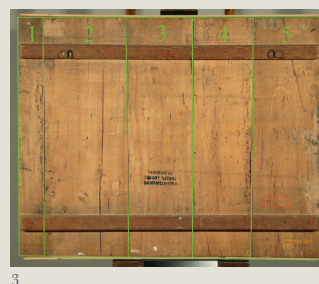
The wooden support consists of five boards (1,2,3,4 – oak and 5 – poplar) glued horizontally (Fig. 1). The surface of the support (dimensions 110.5 x 140.5 cm) is highly deformed. The boards are permanently dome-shape deflected towards the painting face. During one of the previous conservation interventions, the boards of the support were thinned (to 0.5 cm thickness) and then glued and nailed to the new support. The new support, called “transfer support”, consists of five boards (poplar of approx.: 2 cm thickness) assembled vertically and reinforced by two horizontal cross beams (approx.: 3 cm thick) (Figs. 2, 3). The boards of the original support are unglued and cracked, and partly detached from the transfer support.

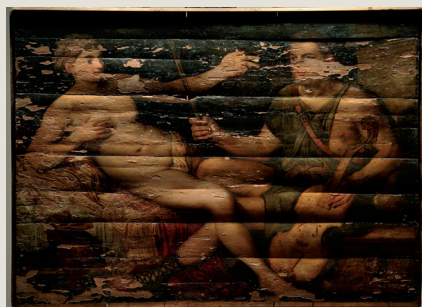
Observation of the painting in daylight and analytic (UV, IR) light shows a wide spectrum of damage to the different technological layers (Fig. 4, 5, 6).
