Linking climate to observed damage – assessment of storage conditions for polychrome sculpture & frontals at Museum of Cultural History (KHM).

Jeremy Hutchings (Associate Professor, Conservation Studies IAKH, UiO), j.d.hutchings@iakh.uio.no

Kaja Kollandsrud (Senior conservator of paintings & polychrome sculpture KHM, UiO), kaja.kollandsrud@khm.uio.no, blogg: <http://folk.uio.no/kajak/>

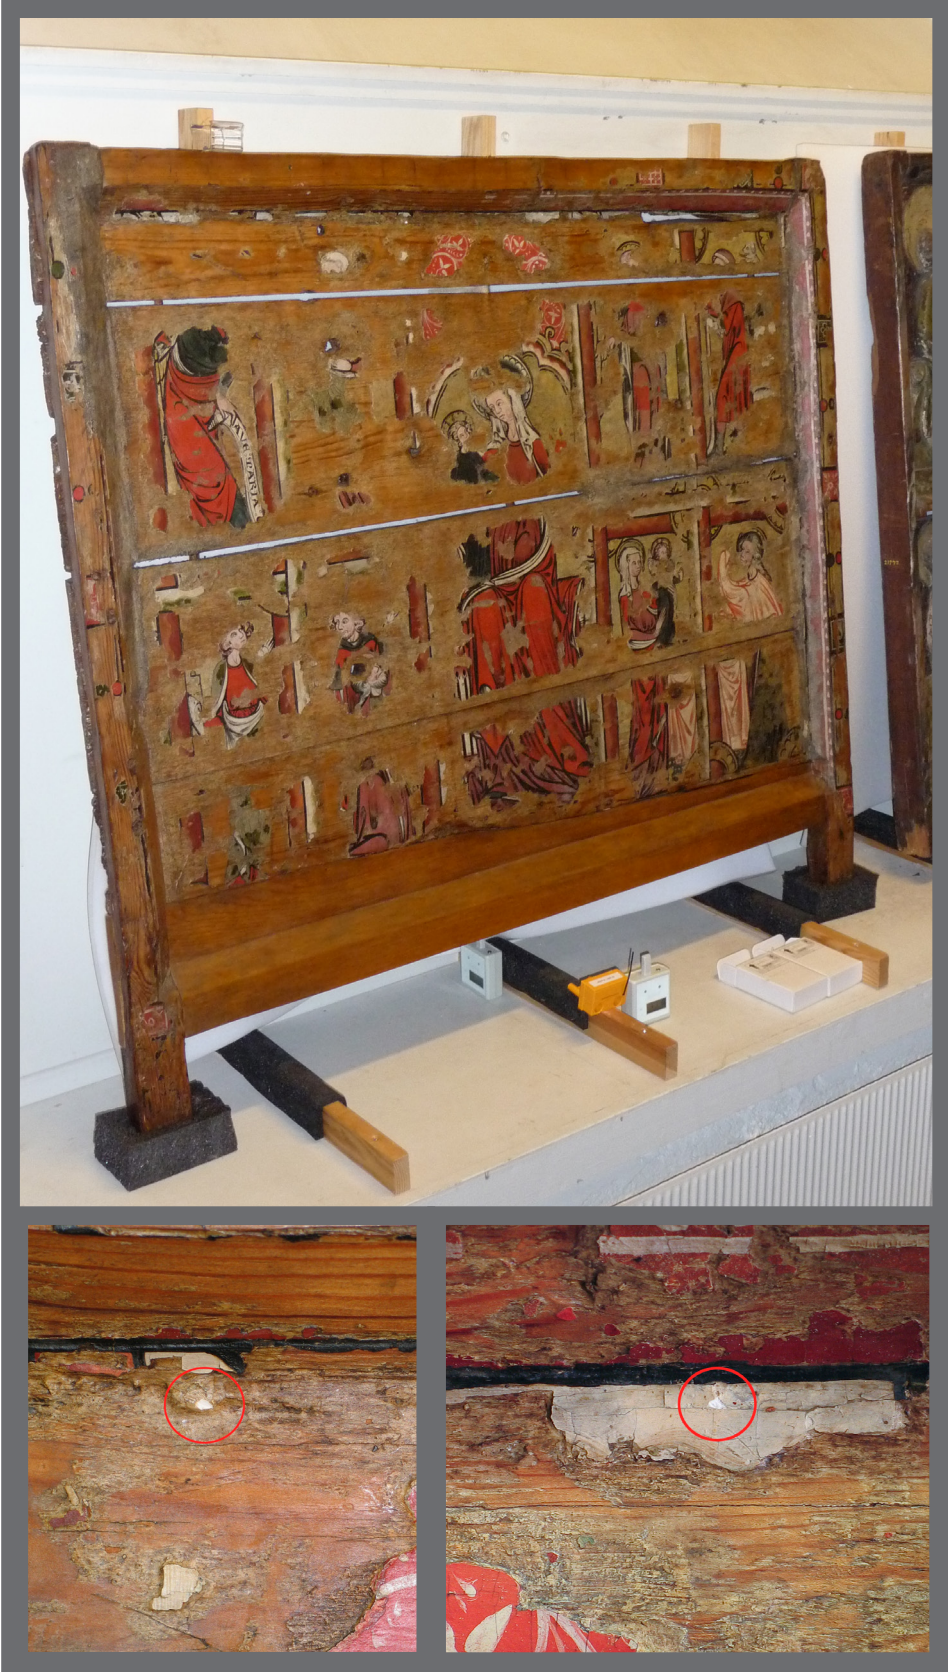
Due to the value of the collection even the smallest deterioration is of concern and is therefore worthy of investigation. The collection underwent a general emergency treatment in the late 60's and early 70's. Since that time only minor damage has been observed, leading to the opinion that the environmental conditions have been stable and suitable. In such a valuable collection it is the cumulative effect of minor damage and the triggers for such damage that is interesting to this project (See figure 2).

Fig 2 Damage that has occurred in the paint layer since the restoration of the frontal from Øye, Oppland C17806, in 1975. The objects has kept in this store since that date.

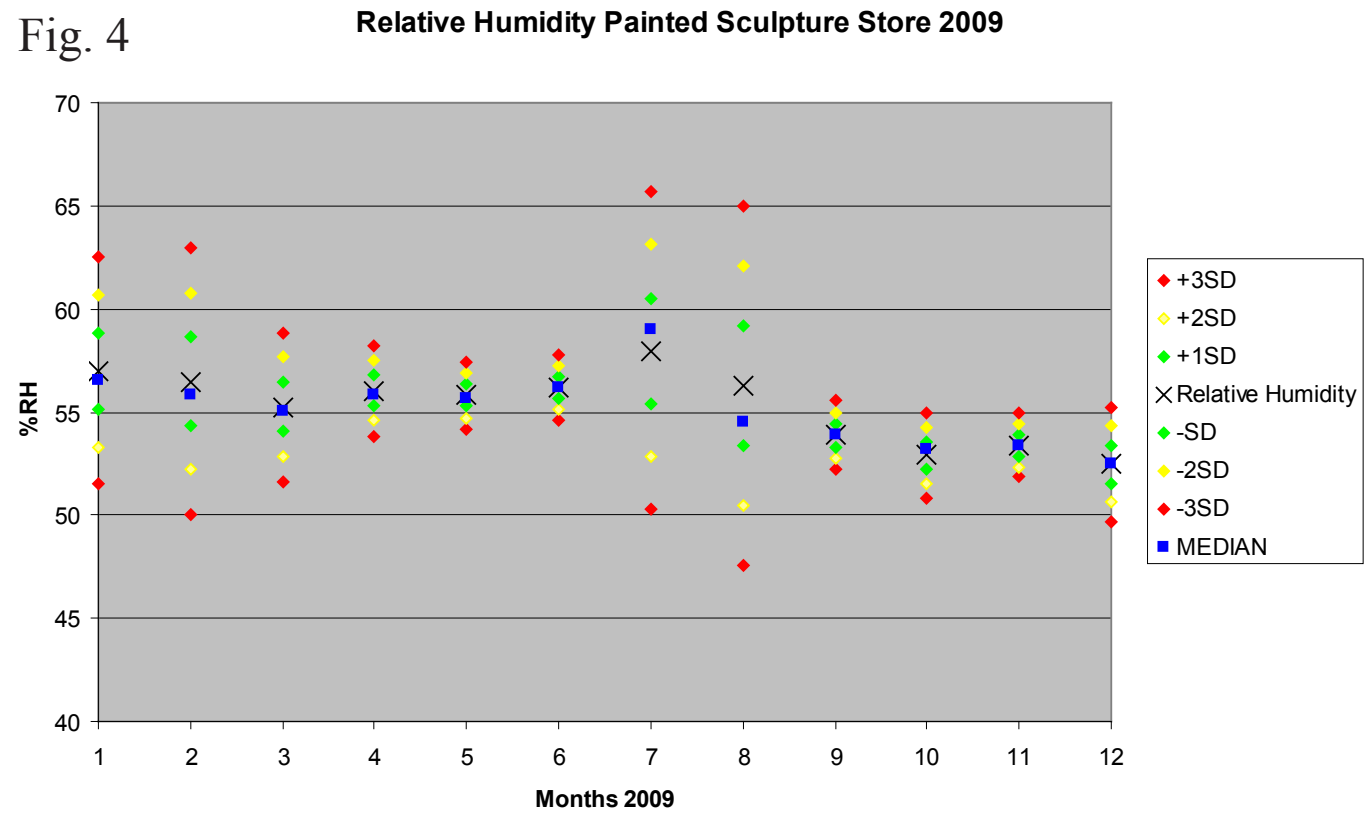
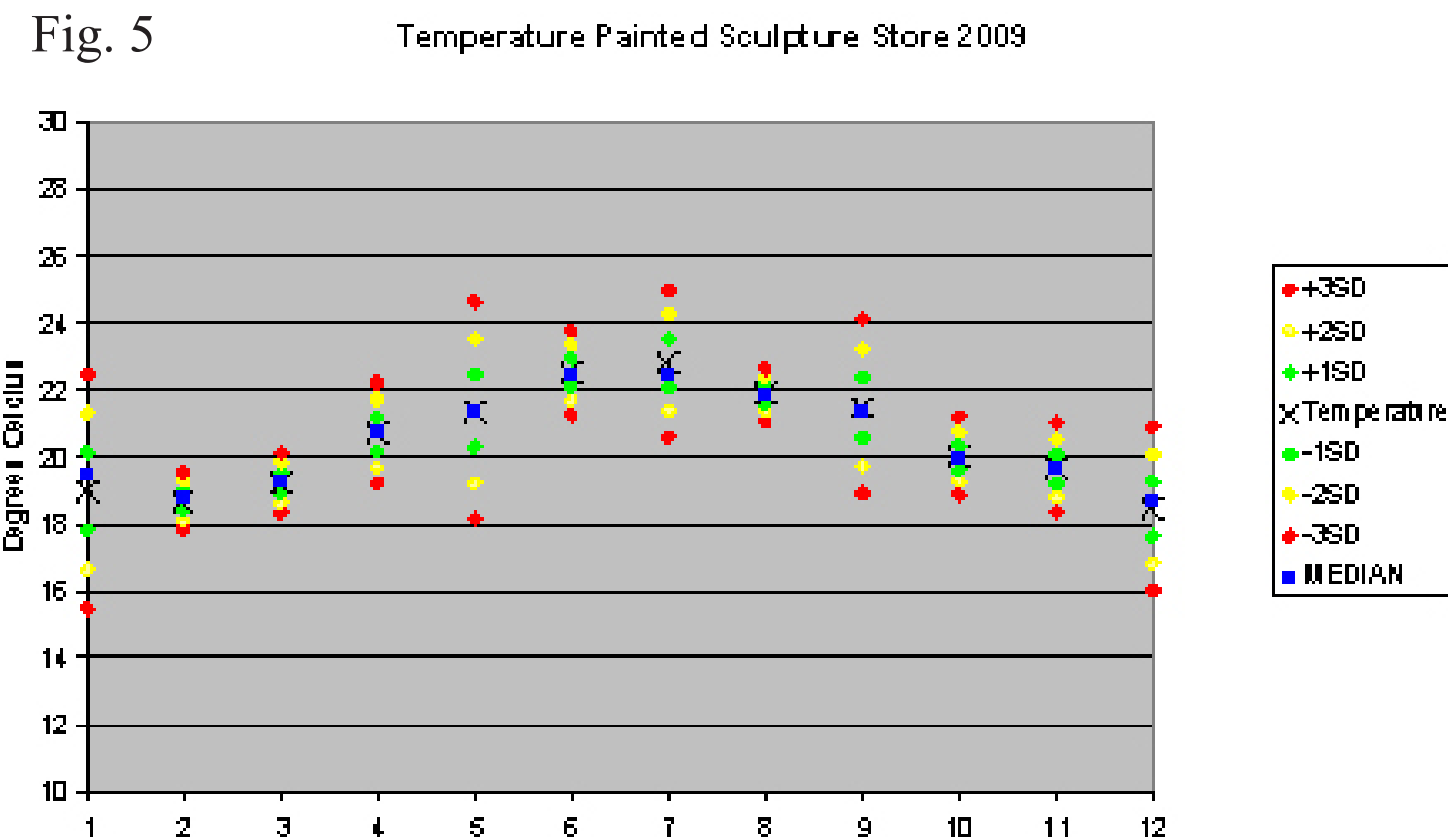
crosses in figure 4 indicate the monthly mean relative humidity. The blue dots represent the median value. The range between the two green points represents conditions 68% of the time, the values between the yellow points 95% of the time and the values between the red points 100%. The data shows that during March to June and September to December 2009 the conditions were very stable. The widest variance is under $\pm 4\%$ with conditions during the majority of time remaining within $\pm 2\%$. Even in January, February, July and August 2009 the conditions remain within $\pm 5\%$ for 95% of the time.

The distance between the average value and the median illustrates the level of asymmetry in the data. For example in July the median is just over 1% above the mean and in August the median is approximately 1.7% below the mean.

In months with the least deviation the mean and median are approximately the same. The skewness of the dataset provides an understanding of the distribution of data. In this case it shows that the tail of the distribution is longer towards the upper values in July and towards the lower values in August suggesting that the mean RH is biased in those directions for those months.

This is supported by the weekly charts which show two events: a gradual drift from 55% to 60% over a two week period after which the conditions remain at the upper level for a further two weeks and then is suddenly readjusted back to 55%. A similar event occurs at the beginning of August when the relative humidity rises over 5 days to 63% after which it drops over the same period of time back to just under 55%. Both incidents prompted the replacement of the dehumidifier on the 10th of August. No further events took place in that year.

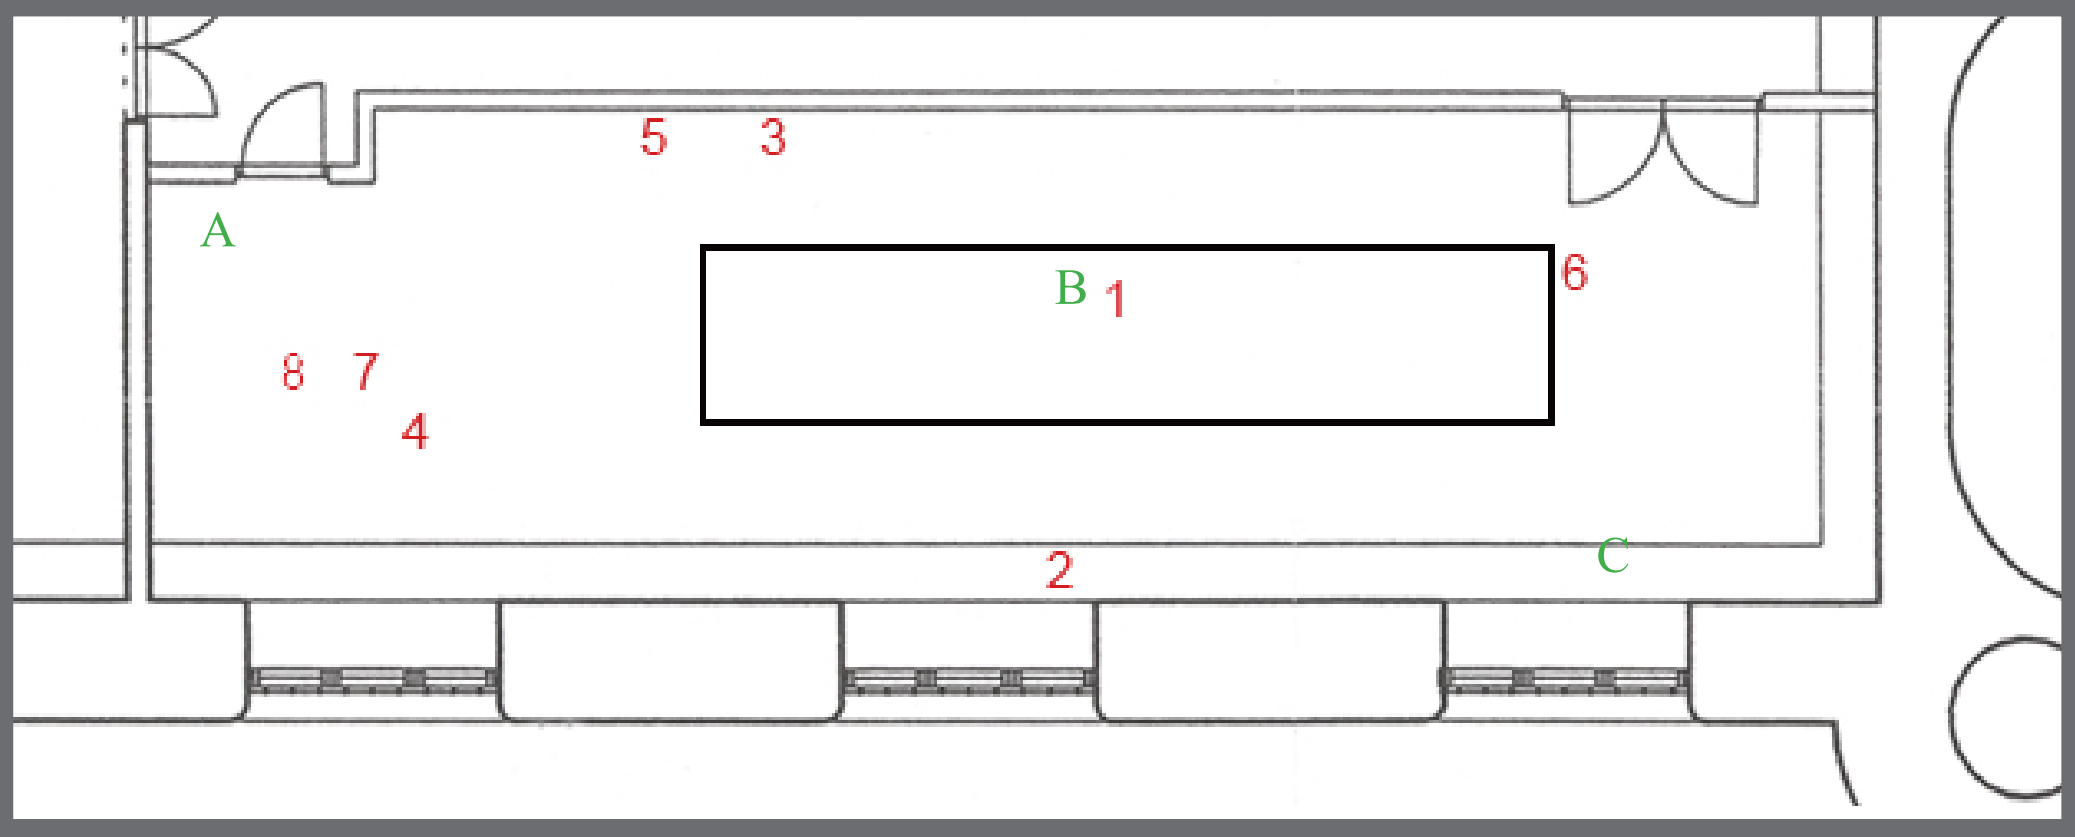
The dust appears to be quite evenly distributed throughout the room when taking into account that some of the areas have been covered or cleaned more frequently. The samples show a relatively low proportion (~1.5%) of skin flakes, textile fibres and human hair. This was not unexpected as the storage area does not experience a lot of human traffic. A reasonable proportion (~14%) of the dust is black amorphous particles that look like soot. Many are a uniformly small size which may have come from outside. This is expected in a building situated in the center of Oslo. A small amount of larger particles is thought to come from the air conditioning before it was blocked.

Fig. 6 Sample 1-8: Dust samples collected at different height and locations of the store room. Sample A-C: "Oddly tests".

What was surprising was the large proportion of fairly similarly sized sharp mineral grains, representing by far the largest proportion of dust (~83%). A significant number of glass fibres were also recorded. The large amount of wood fibres sampled from the upper-shelf is associated with the storage of a degraded piece of wood that has been removed.

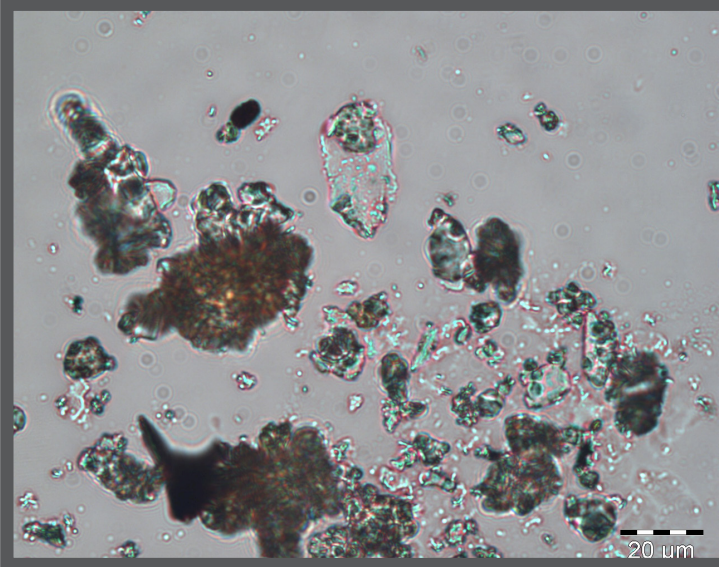
Fig 8 Dust in reflective light 200x.

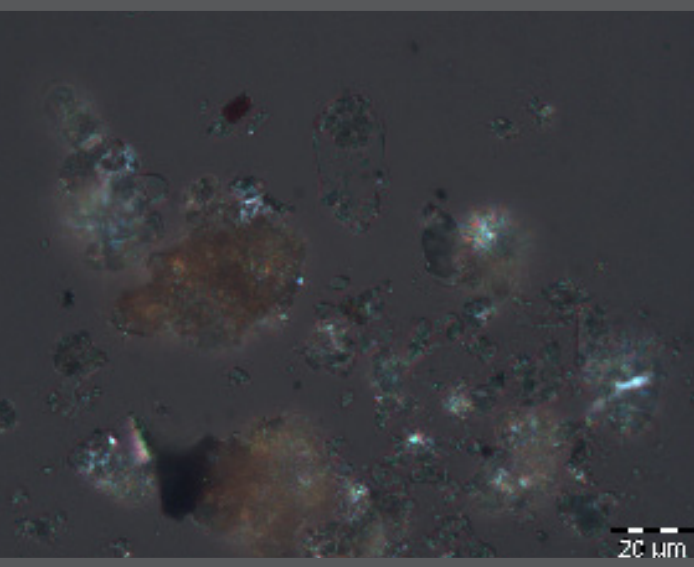
The mineral grains were examined in dark field polarized light. The largest proportion was small sharp water-white grains that are suggested to be quartz. These do not have a grain structure and do not interfere with the light in crossed-polarization suggesting that they have a uniform crystal structure. There are a small proportion of larger colourless grains exhibiting interference colours which suggests muscovite. Occasional large, cubic grains can be seen which have tartan or grid twinning. This suggests feldspar and other smaller grains are light brown and semi transparent with lesser interference colours suggesting biotite. No extinction angles were calculated so identification can only be tentative. A more definitive identification will be undertaken in the near future. The combination of quartz, biotite, muscovite and feldspar suggests a granite source.

Fig 9 is fig. 8 in polarized light showing some birefringence.

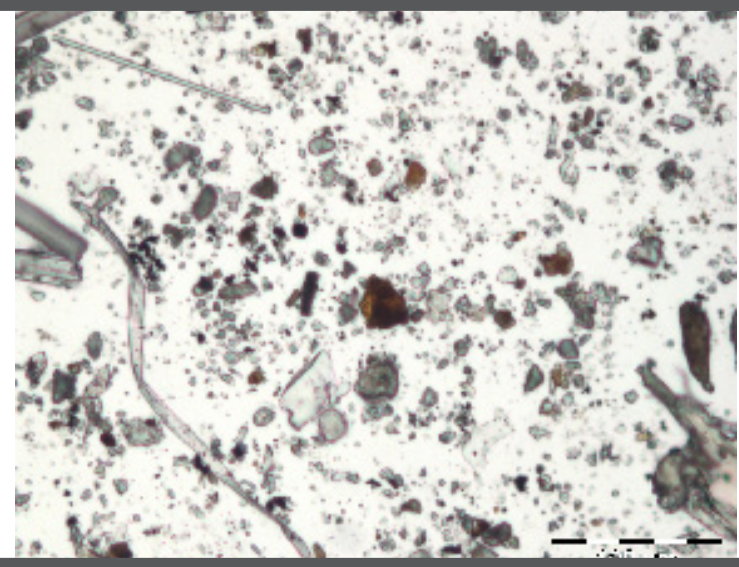
The large amount of small size minerals in the dust is likely to have come from the repaving of the front of the museum with white granite in 2006, when the stone was cut to size on site. Whilst this type of dust is not considered to be a major agent of deterioration for polychrome wood, it may contain mobile salts and may cause abrasion which indirectly jeopardizes the condition of the collection. The large amount of mineral dust detected demonstrates the risks from dust associated with building work in the vicinity of a museum and the importance of dust monitoring as part of a wider environmental monitoring programme. The detection of fibre glass suggests that insulation work has occurred which is probably associated with the air conditioning ducts. Whilst not representing a significant risk to the collections it may pose a health risk that needs to be mitigated. The ongoing dust monitoring will be able to identify whether the composition of dust has changed and its rate of deposition.

Fig 10 A typical dust sample showing the amount of sharp edged minerals 200x. Note the glass fibre rod in the upper left corner 200x.

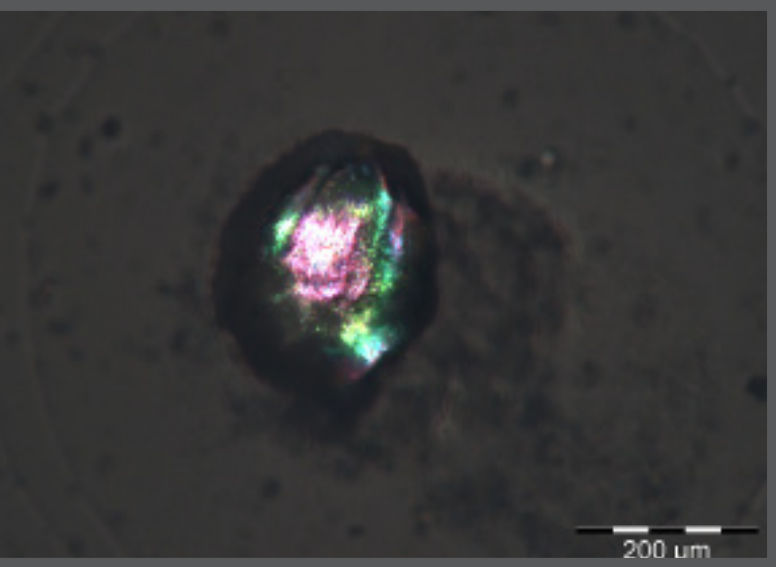
Fig 11 Large birefringent particle 500x.
