Acoustic emission for assessing risk of climate-induced damage: monitoring the altarpiece in the church in Hedalen, Norway

Wooden stave church in Hedalen, Norway.

Built 12-13th century, extended in 1600 and 1730.

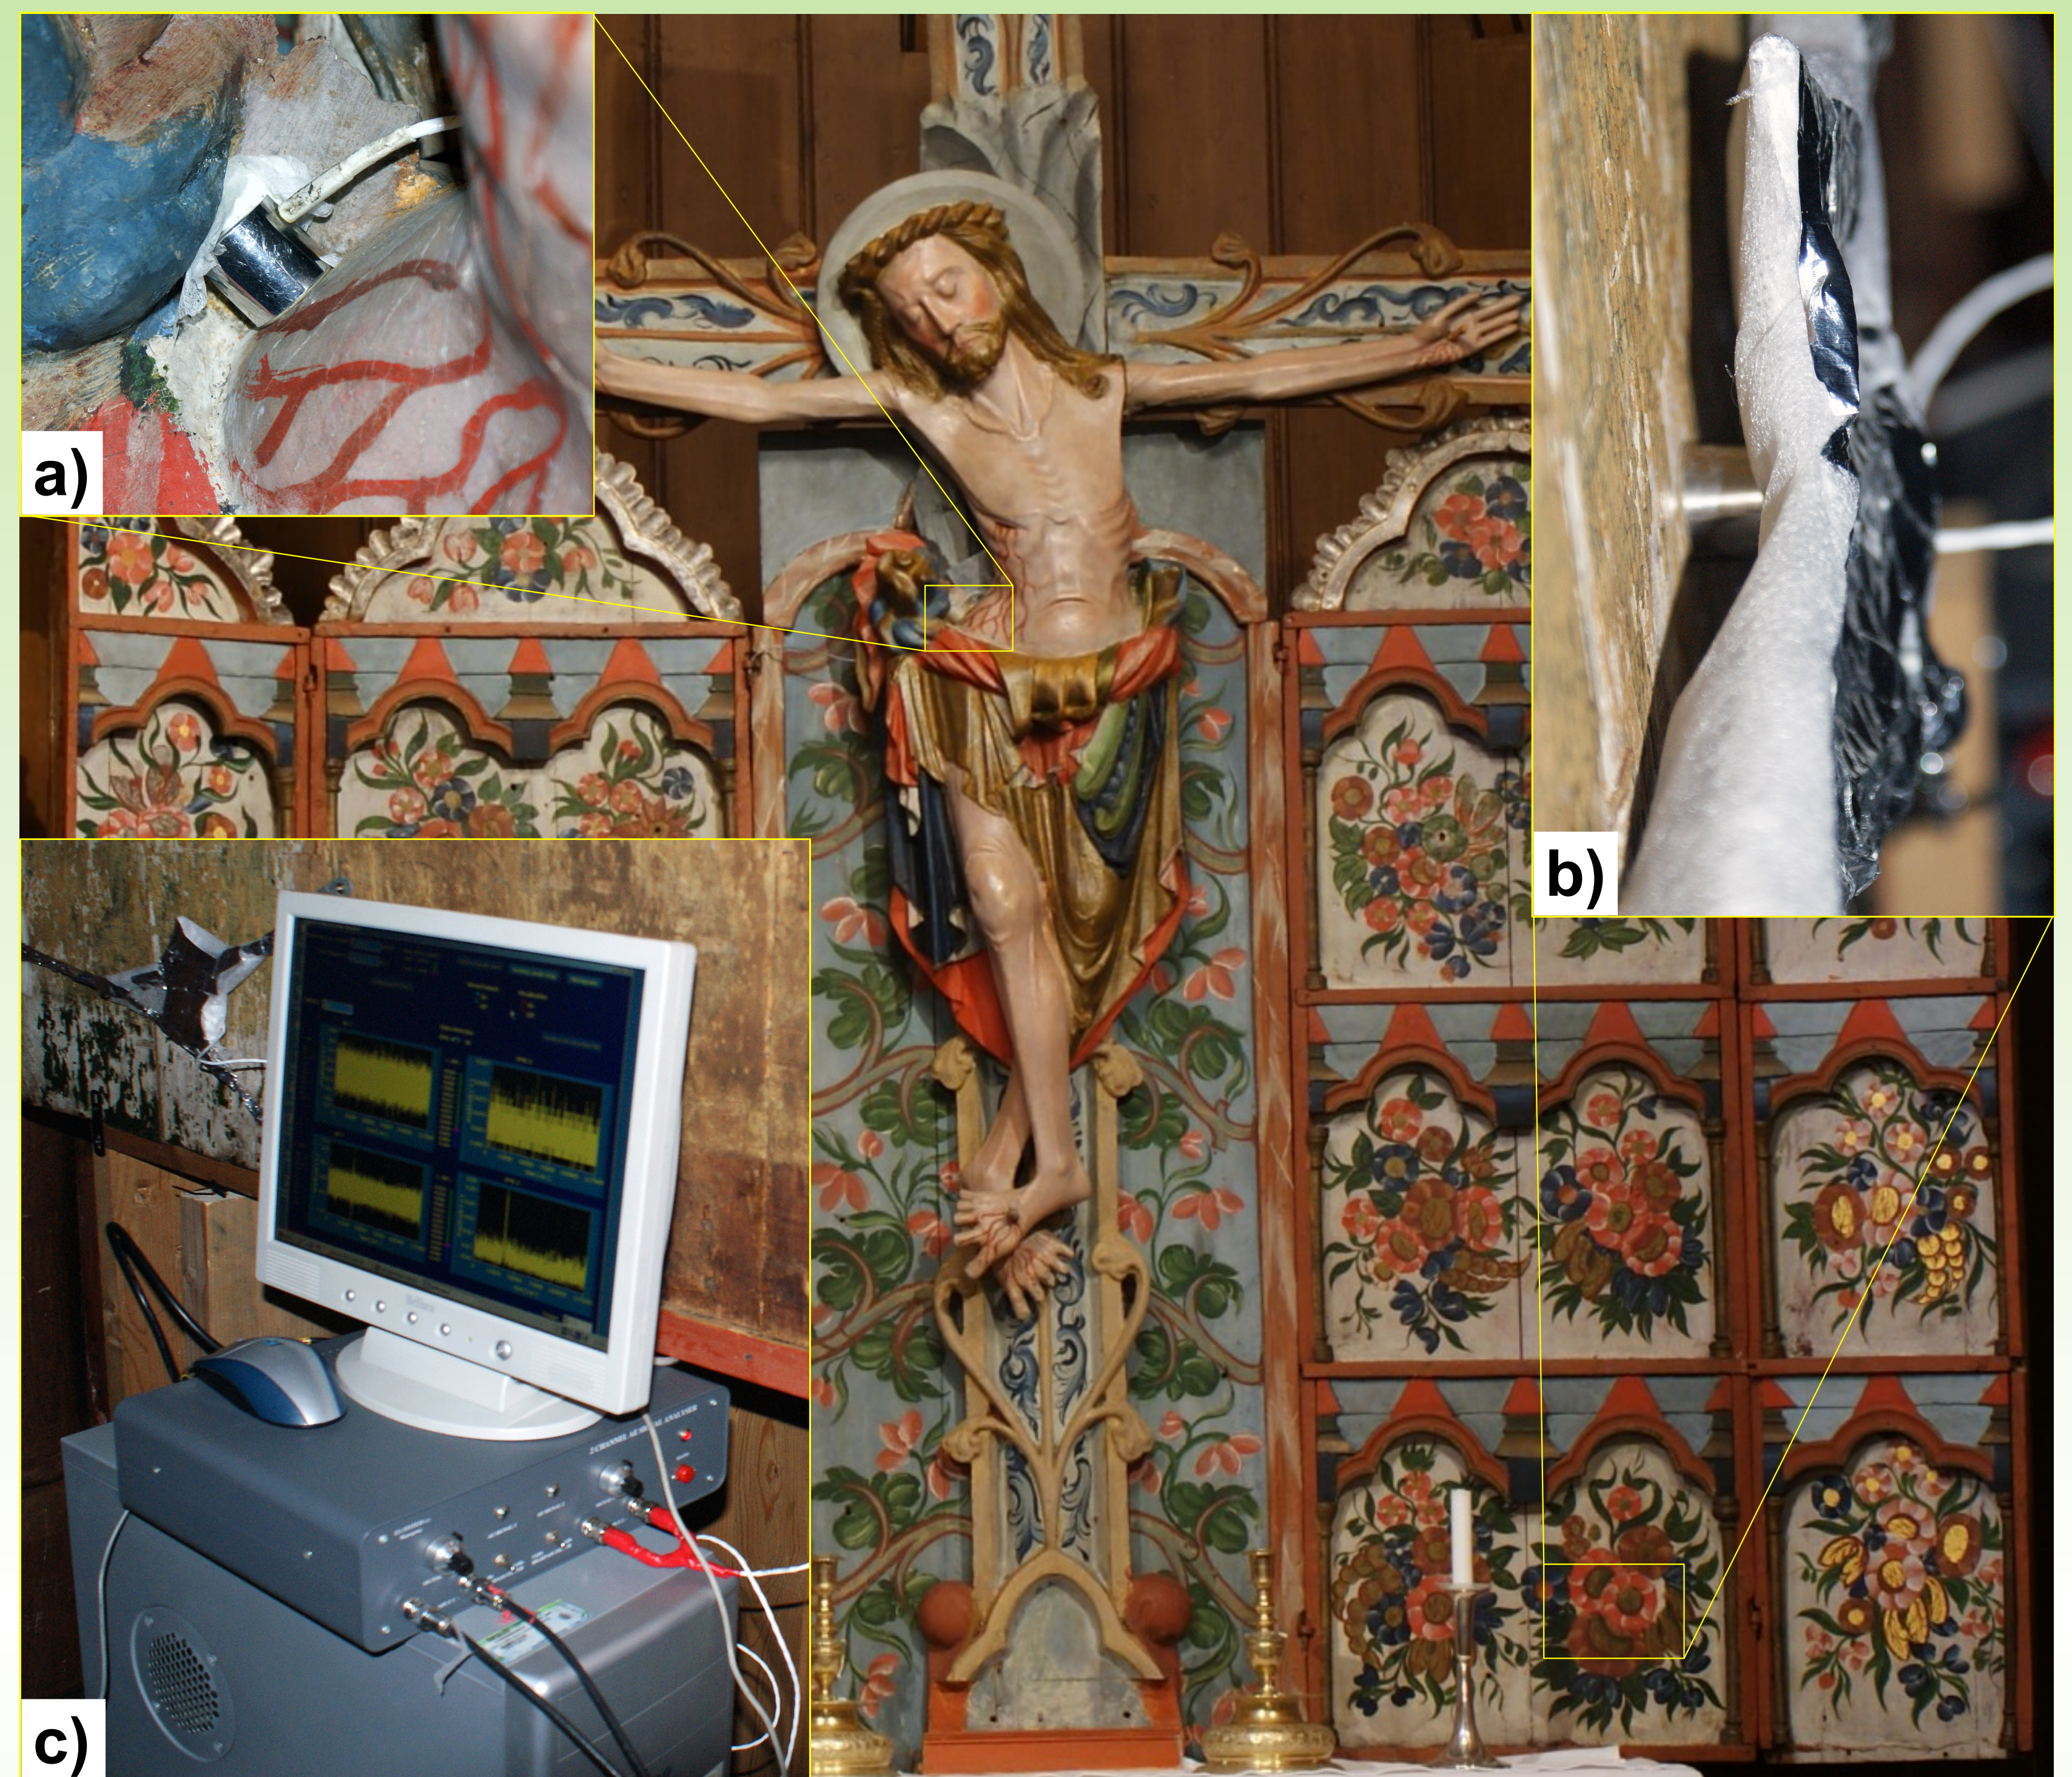
The altarpiece

A medieval wooden polychrome crucifix mounted in a thirteenth century tabernacle redecorated in the eighteenth century. System measuring acoustic emission: (a) sensor 1 mounted on the massive wooden figure of Christ, (b) sensor 2 mounted on a thin painted panel, (c) amplifier connected to a computer recording captured signals.

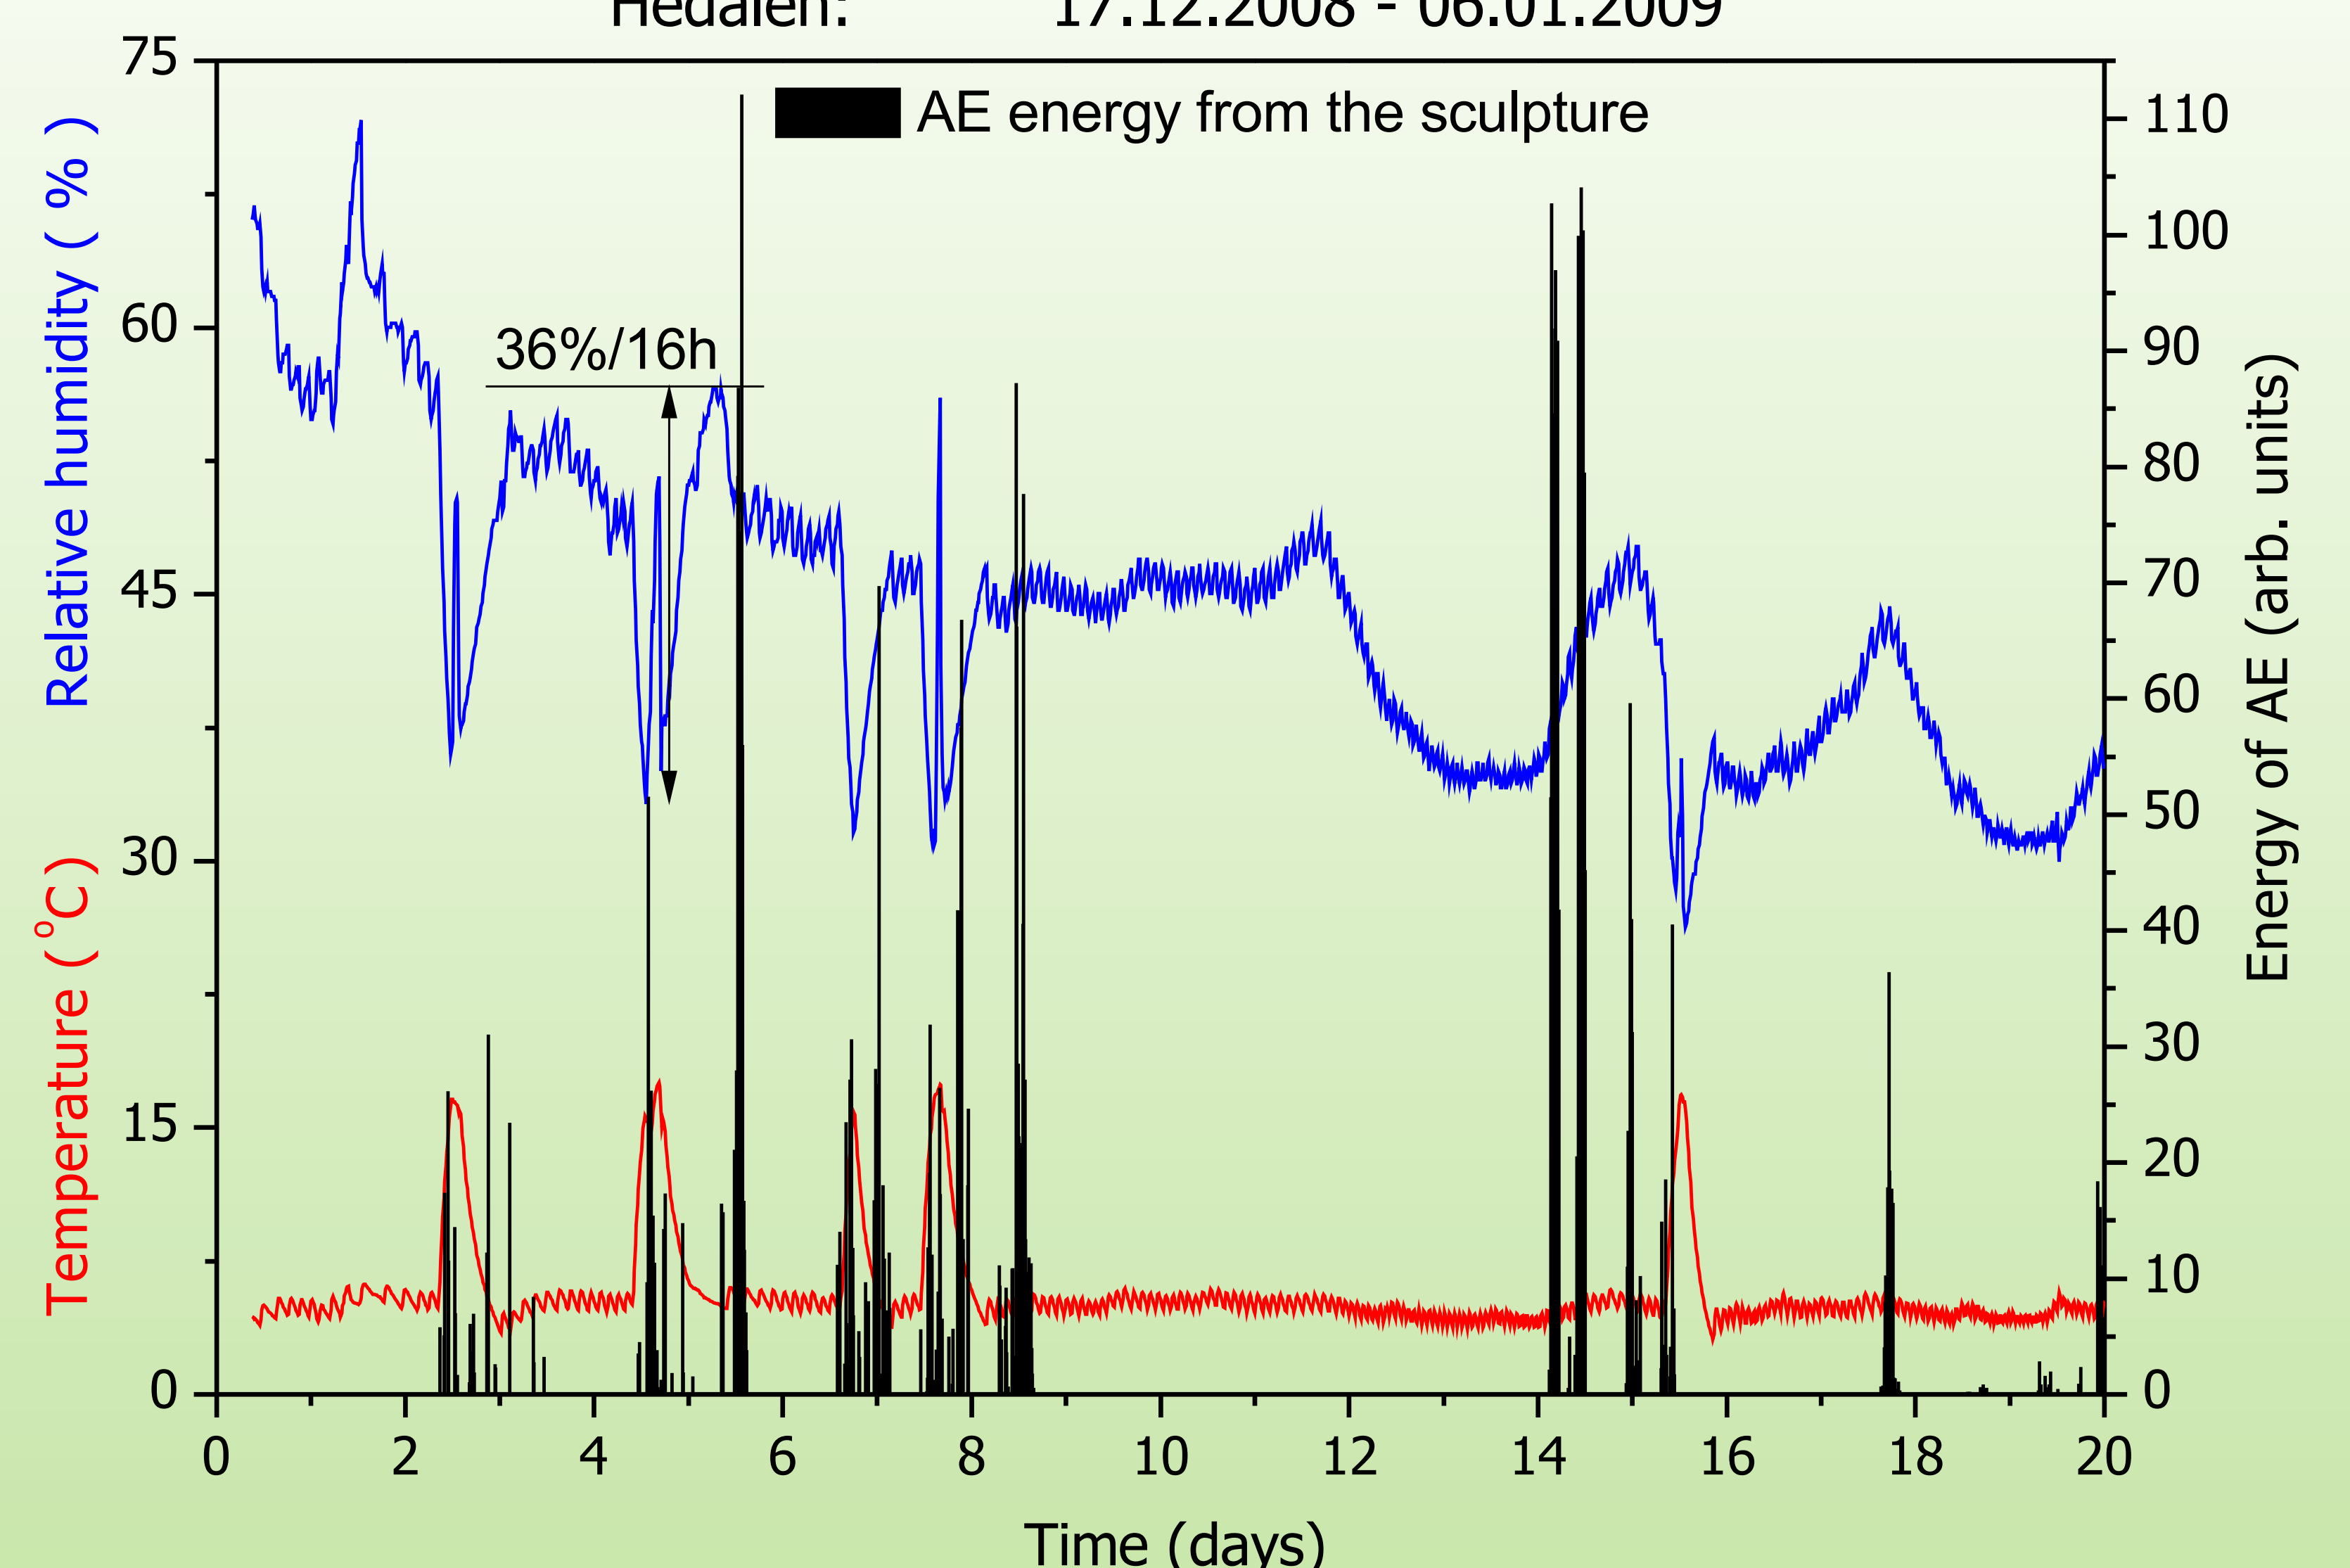
Hedalen: 17.12.2008 - 06.01.2009

The **panel** is not a matter of concern – no AE events were captured.

The **sculpture** is a matter of concern – AE events correlated with climate variations were recorded.

Good correlation between AE signals captured from the sculpture and fluctuations of relative humidity and temperature is observed. The highest amplitude of AE signal was measured after 36% increase of RH over 16 hours.
