A 16TH CENTURY WOODEN POLYCHROME CRUCIFIX: FROM A PASSIVE TO AN ACTIVE MICROCLIMATE

Michael. Formosa

Conservation Division, Heritage Malta, Malta Institute of Conservation and Management of Cultural Heritage, University of Malta,

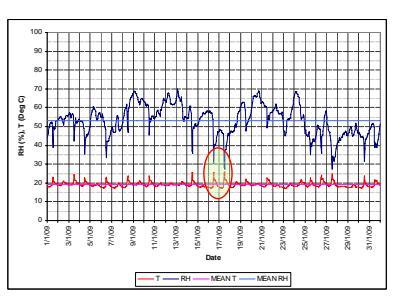
Hourly readings and mean RH and T for the month of January 2009

A rise of T was accompanied by a drop in RH and vice versa. Figure below right]. Rapid fluctuations were quite rapid. For example on the 9th January 2009, between 10:00 and 11:00, there was a sharp rise in T of 7.28°C and a drop in RH of 21.3%. [Figure below]

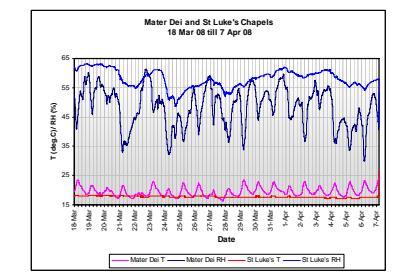
nd St Luke's Chapels – T and RH di Both Temperature (T) and Relative Humidity (RH) at MDH Chapel fluctuate more

than at the chapel at SLH, the possible reason being the air-conditioning system. Mean T and RH throughout the twenty one days were as follows:

T: MDH Chapel 19.5°C, SLH Chapel 17.7°C RH: MDH Chapel 48.2%, SLH Chapel 58.0%

When comparing the two chapels it is clear that the mean T at the chapel of SLH was 1.8°C lower than that at MDH, while the RH is greater by almost 10%. Some regions of rise and fall in RH can be noted simultaneously at both chapels and this may be attributed to the external environment.
