A 16TH CENTURY WOODEN POLYCHROME CRUCIFIX: FROM A PASSIVE TO AN ACTIVE MICROCLIMATE

Michael. Formosa

Conservation Division, Heritage Malta, Malta Institute of Conservation and Management of Cultural Heritage, University of Malta,

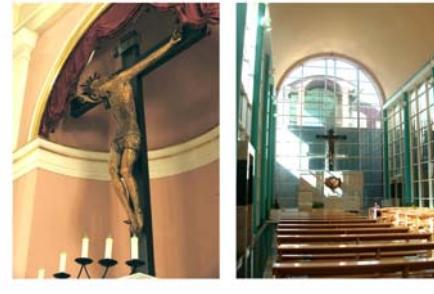
Chapel at Mater Dei . Hospital

The four walls of the chapel are glazed. Light levels during the day are excessive. The climate inside the chapel is controlled by an Air Handling Unit system set at a temperature of 21°C.
